Analysis of factors contributing to roadside tree crashes in South Carolina

ANALYSIS OF FACTORS CONTRIBUTING TO ROADSIDE TREE CRASHES IN
SOUTH CAROLINA

A Thesis
Presented to
the Graduate School of
Clemson University

In Partial Fulfillment
of the Requirements for the Degree
Master of Science
Civil Engineering

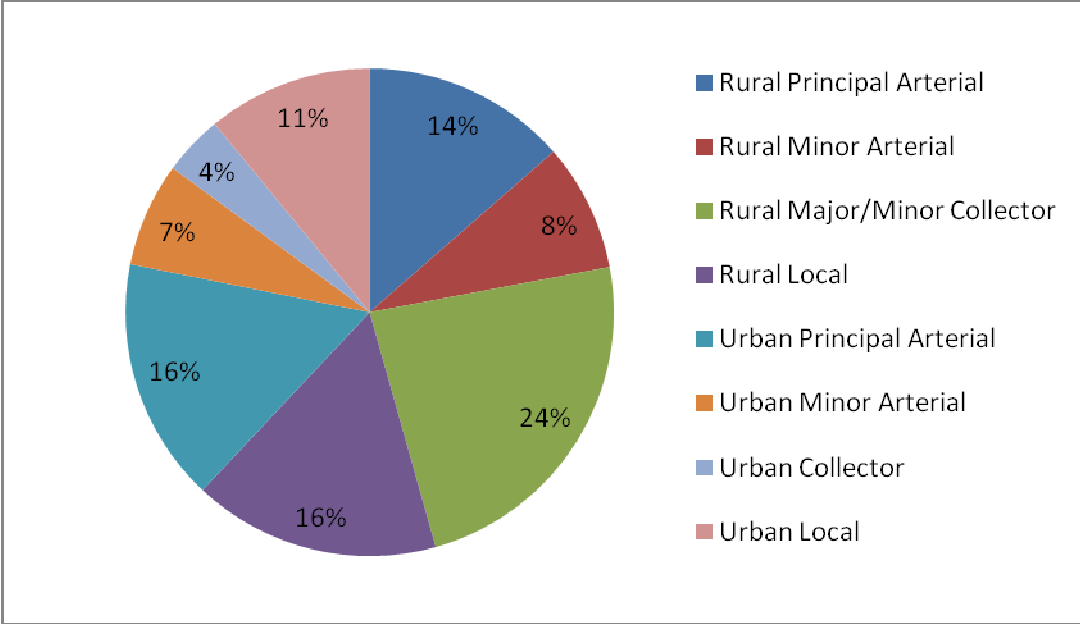
Figure-1, Fatal Tree Crashes by Functional Class (2008 FARS data)

Figure-1 shows the distribution of fatal crashes based on the roadway functional classification. Rural roads accounted for approximately 62% of fatal crashes against 37% on urban roads. About 24% of all the fatal tree crashes occurred on the rural major and minor roads followed by 16% on rural locals and urban principal arterials.

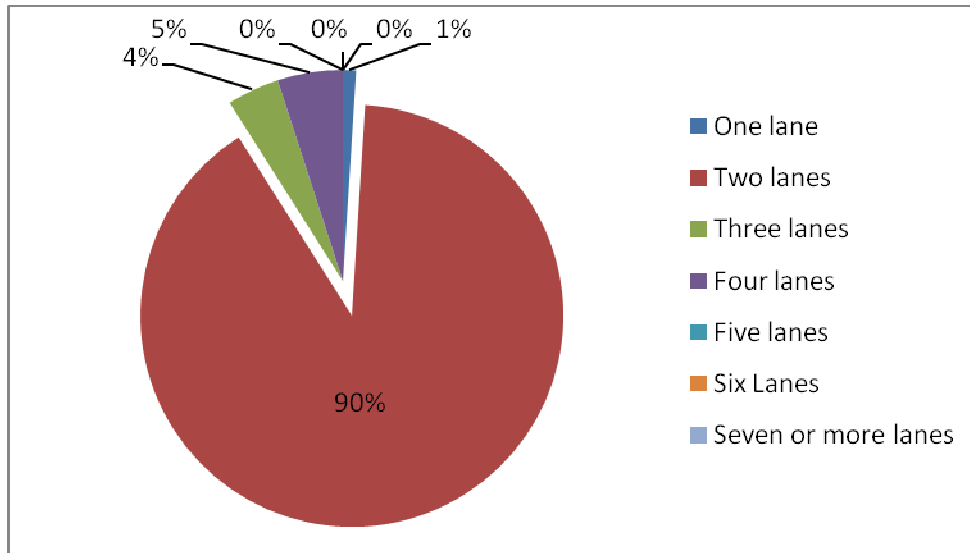
Figure-2, Fatal Tree Crashes by Number of Travel Lanes (2008 FARS data)

Out of 2900 fatal tree crashes approximately 90% of them occurred on the two-lane roads and about 5% occurred on the four-lane roads (Figure-2).

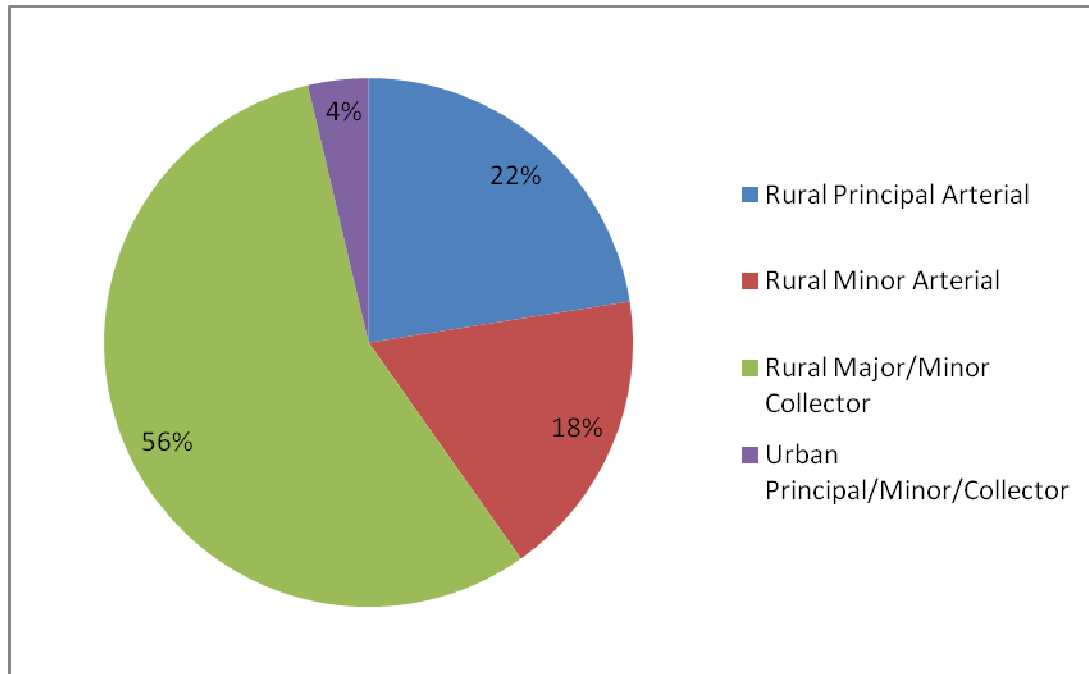
Figure-3, Fatal tree crashes in South Carolina by functional class (2008 FARS Data)

Figure-3 shows the distribution of fatal tree crashes based on the function classification. Rural roads account for 96% of the fatal crashes against 4% urban roads. And 99% of these crashes occurred on rural two lane roadways (2008 FARS Data).

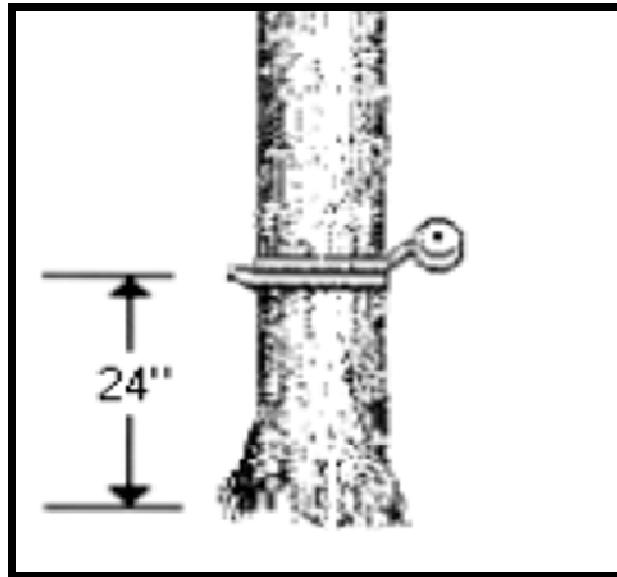
Figure-4, Measuring Tree diameter

For the trees located on the roadside, the first step in deciding what must be done to provide the safest facility is specifying at what size trees become potentially hazardous. The forestry industry uses tree trunk diameter as an important description of trees. The measurements should be taken at the "bumper" height which is the typical height of impact, accepted to be near two feet above the ground.

A typical post used for sign support on the roadside has a size of four inches by four inches. Engineers therefore assume trees with a diameter of four inches are a hazard. For the purpose of efficiency and simplicity, organizations producing manuals and policies on this topic may choose to allow measuring the circumference of the tree trunk, instead of the diameter, at a height of two feet above the ground. Table-2 below suggests values used to determine if a tree is potentially hazardous to errant vehicles.

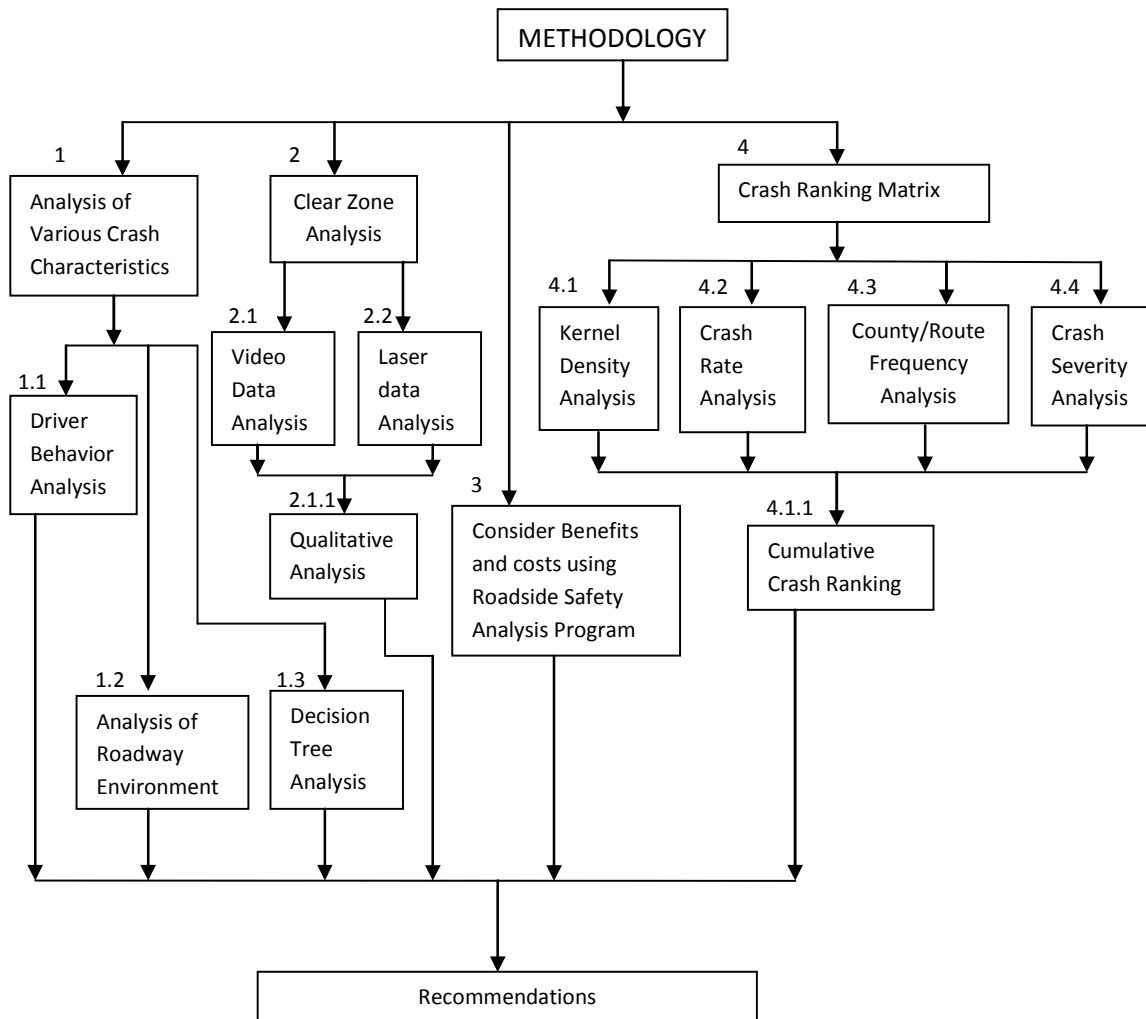
Figure-5, Various stages and steps taken to achieve thesis objectives

The following flowchart identifies the various stages of the approach:

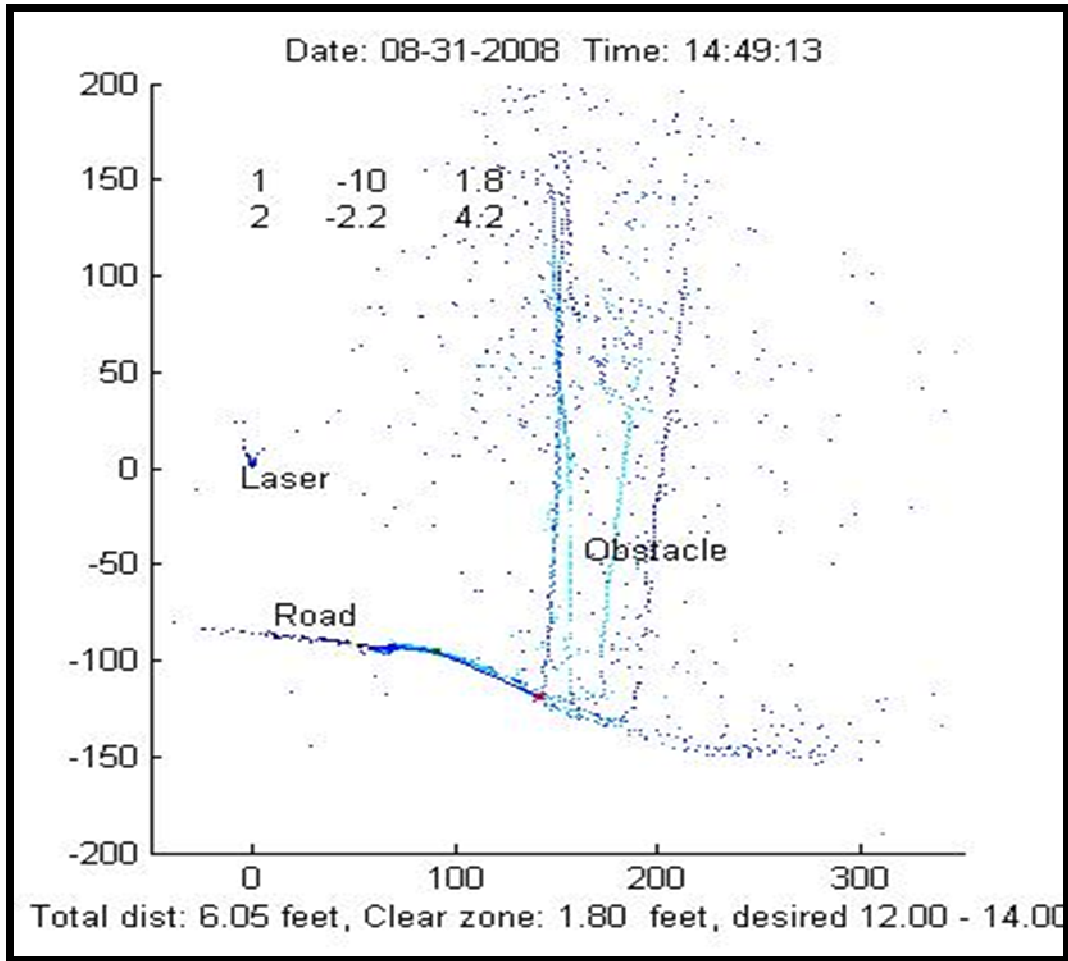
Figure-6, Graphical plot of roadside objects obtained from laser data

The graphical plots of roadside objects and video data were obtained while inventorying the sites using Clemson University mobile transportation laboratory van. The van combines video-log capability with precision GPS location and a laser measurement device that allows capturing roadside features information to the nearest solid object. The laser measurement device secured in the rear side of the van would rotate 360 degrees and takes 400 measurements within one revolution at a rate of 20,000 samples per second and records distance information to the nearest object on the roadside. A custom software was used to manipulate the data obtained from the laser measurement device to display it in graphical format. A graphical plot of the laser data is as shown in the Figure-6.

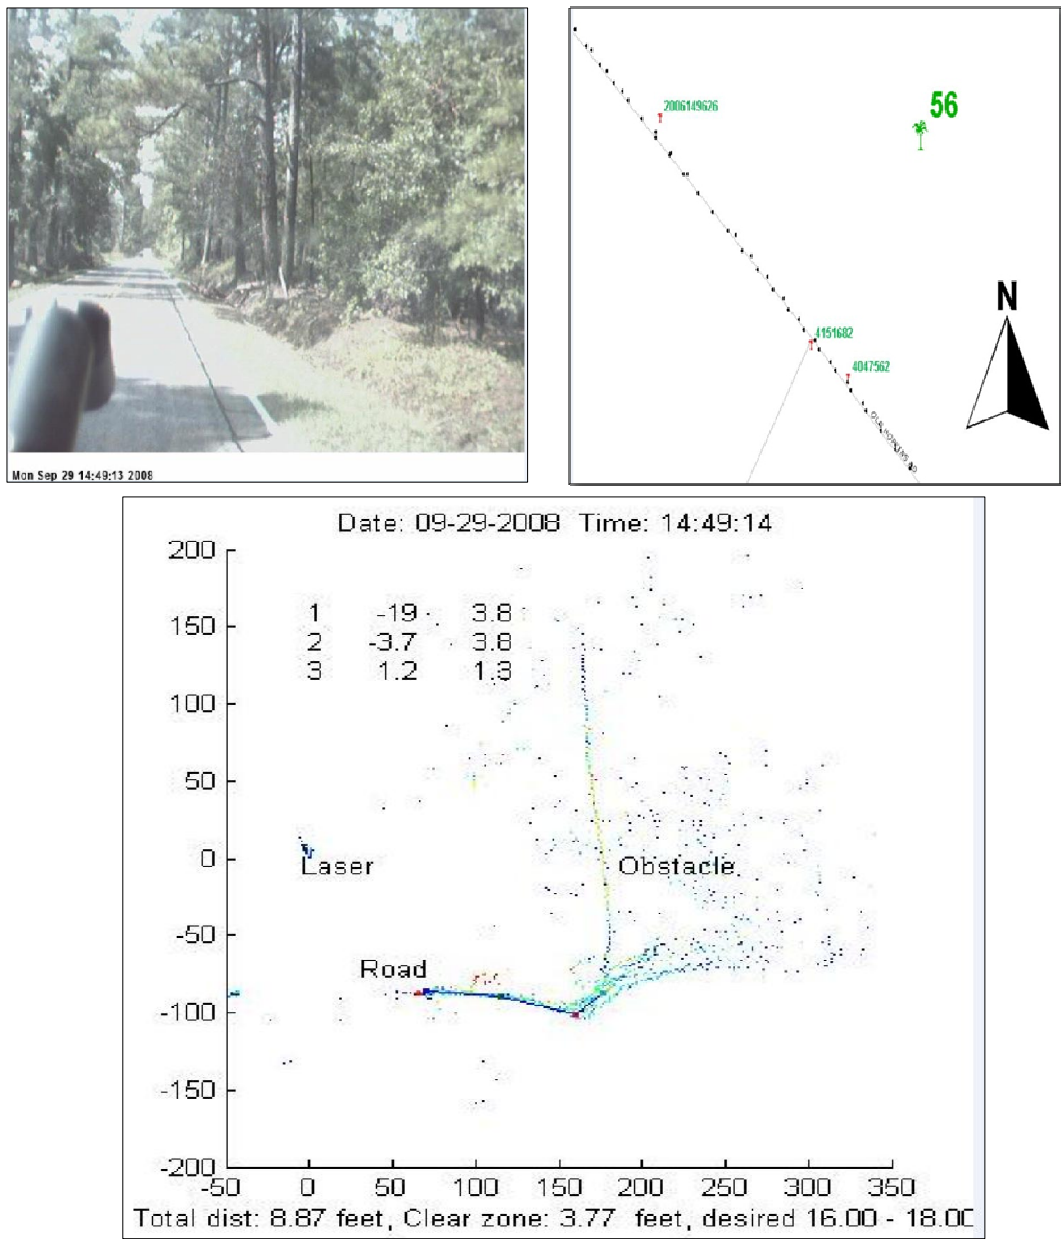
Figure-7, Video log data, GIS data and Laser data

collected by the laser measurement device (Figure-7). All the video log data, laser data and GIS data were linked to each other with a common field “time”.

The laser data had to be calibrated using a known horizontal or vertical surface reference such as a bridge to establish proper z-axis before marking the side slope measurements else the graphical plots would be skewed causing error in the side slopes and distance to obstacles measurements. Once calibrated, the graphical plots were used to calculate distances to roadside trees such as curves.

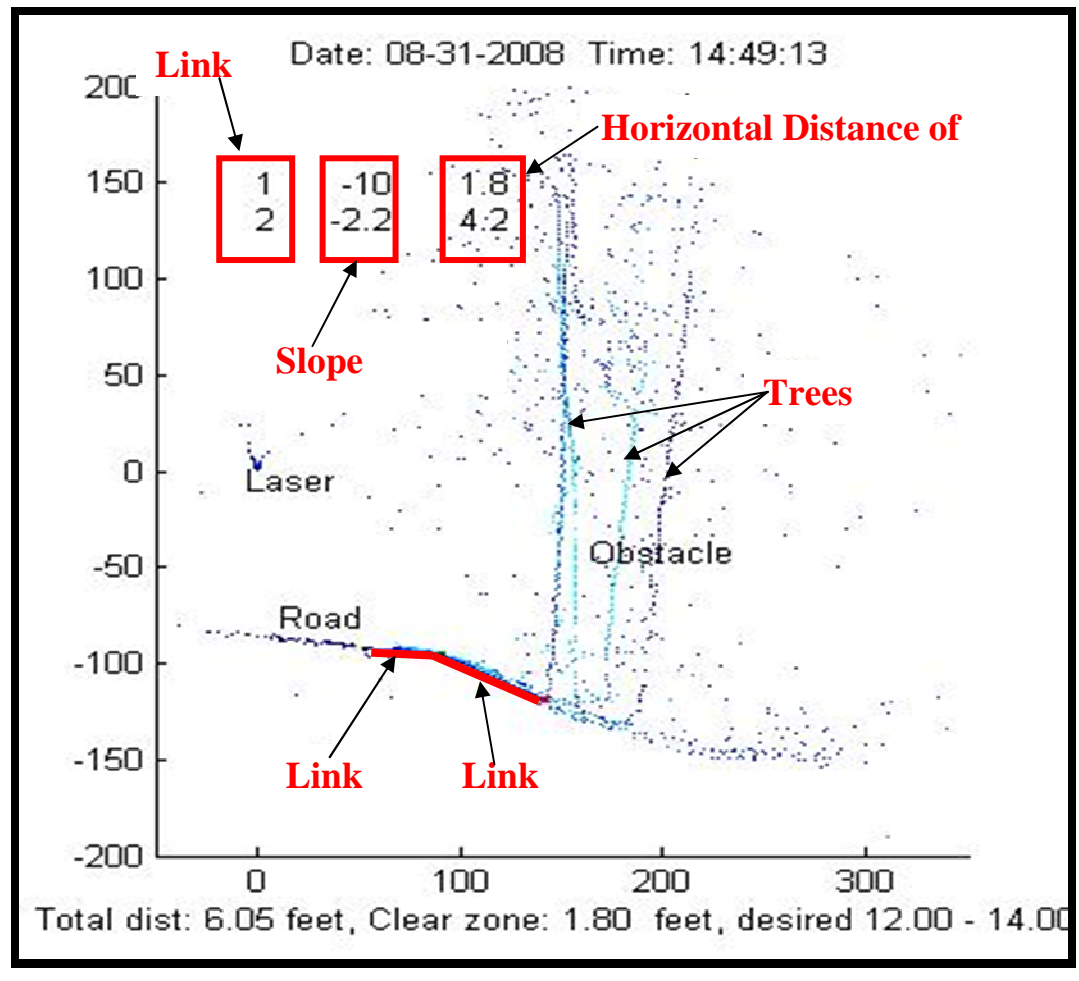
Figure-8, Roadside slope measurement

Once the appropriate laser file was extracted and calibrated, various other details such as speed limit, AADT, and presence of roadside ditch were entered into the software. The software allows users to manually mark multiple linear segments to identify changes in slope on the roadside terrain (Figure-8). By clicking on various points where major side slope changes occur, the software calculates horizontal distances for each segment and provides the slope of individual segments. As shown in Figure-8, as the laser spins, it makes measurements to the first surface edge touched by the laser. The individual dots represent individual measurements. Thus trees, poles, and other solid items appear as linear features.

For the particular measurement shown in the Figure-8, there are 2 slope links. Starting from the edge of the travel lane (identified through changes in luminosity caused by paint markings) the links are drawn to the right until the toe of the tree is reached. The three columns on the top left corner in the Figure-8 represent link number, horizontal slope component of the side slope in $_H:1V$, and horizontal distance of the link. Thus, the link number 1 has a slope of 10H:1V and a horizontal distance of 1.8 feet. Similarly link 2 has a slope of 2.2H:1V and a horizontal distance of 4.2 feet. The software also automatically checks for traversable and recoverable slope status of the links and either excludes or includes

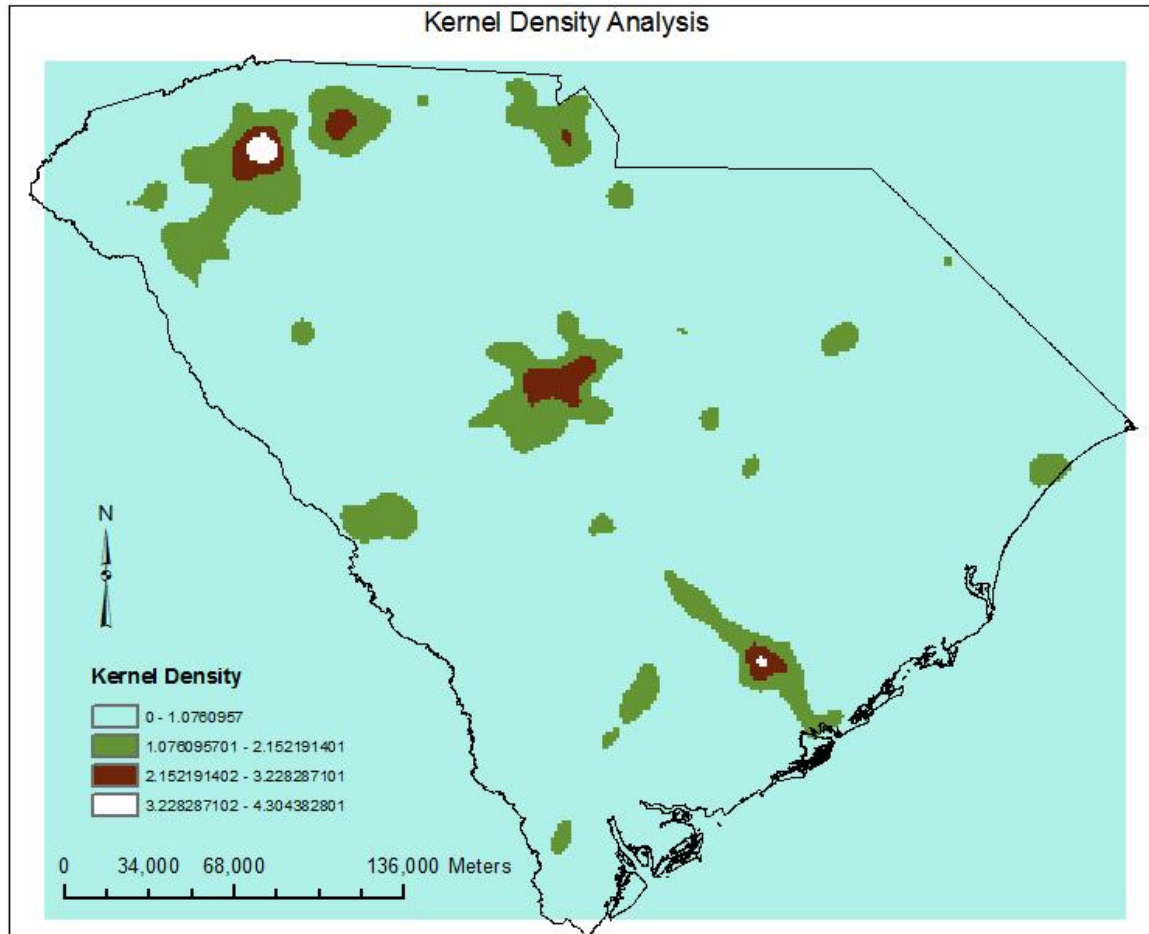
Figure-10, Kernel Density Plot in ArcView GIS software

In order to perform this task ArcView GIS software was used which allows performing advance spatial analysis. The spatial data of all the tree crashes was used to plot the crashes in Arc GIS. The kernel density function calculates the density of trees within an area around those trees. When the analysis is run a smooth curve is fitted around each point. The surface value is highest at the location of the point and diminishes with increasing distance from the point, reaching zero at the search radius distance from the point. The kernel density analysis is available under spatial analyst tools in Arc toolbox. The tree crash data was used as input features and a value of NONE was specified in the population field (if a population field setting other than NONE is used, each item's value determines number of times to count the point). A search radius of 6 miles was specified to plot the kernel density. The density at each output raster cell is calculated by adding the values of all the kernel surfaces where they overlay the raster cell center. Figure-10 shows a picture of kernel density analysis performed in Arc GIS.

After running the kernel density analysis the areas were categorized into 4 different regions based upon the density of crashes per unit area. The crashes in the region of high crash density were given a ranking of one and crashes in the lowest density region were given a ranking of four. All the ANOs were assigned a ranking based upon the region they fall into.

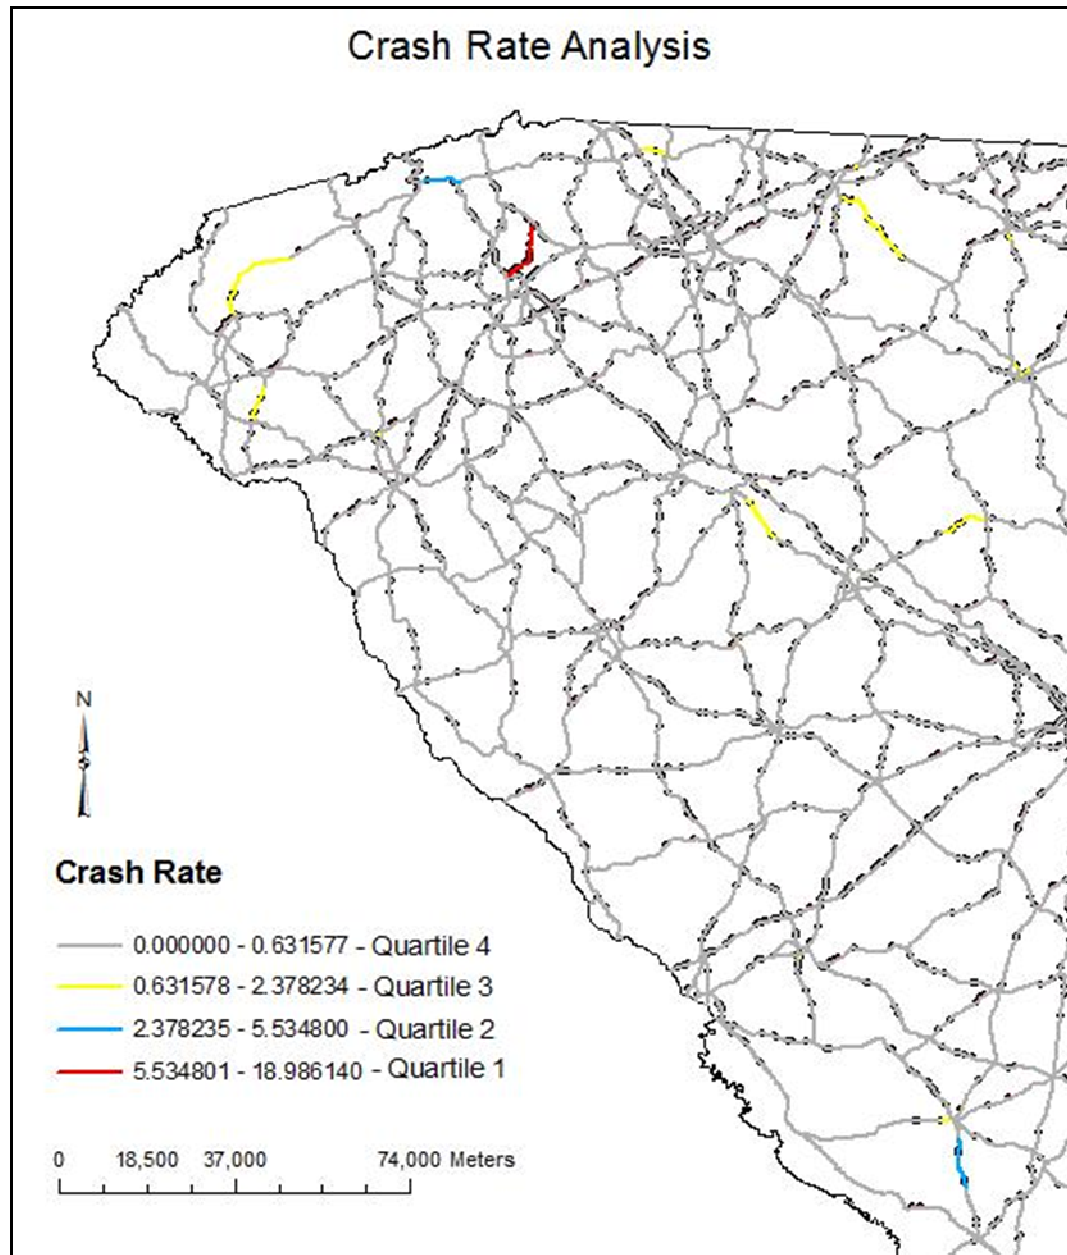
Figure-11, Crash-Rate analysis plot in ArcGIS software.

The sites with the highest quartile crash rates were ranked 1 and sites in the second quartile were ranked 2 and so on with the lowest crash rate quartile having a rank of 4. Figure-11 below shows the map of crash rate analysis performed in ArcGIS:

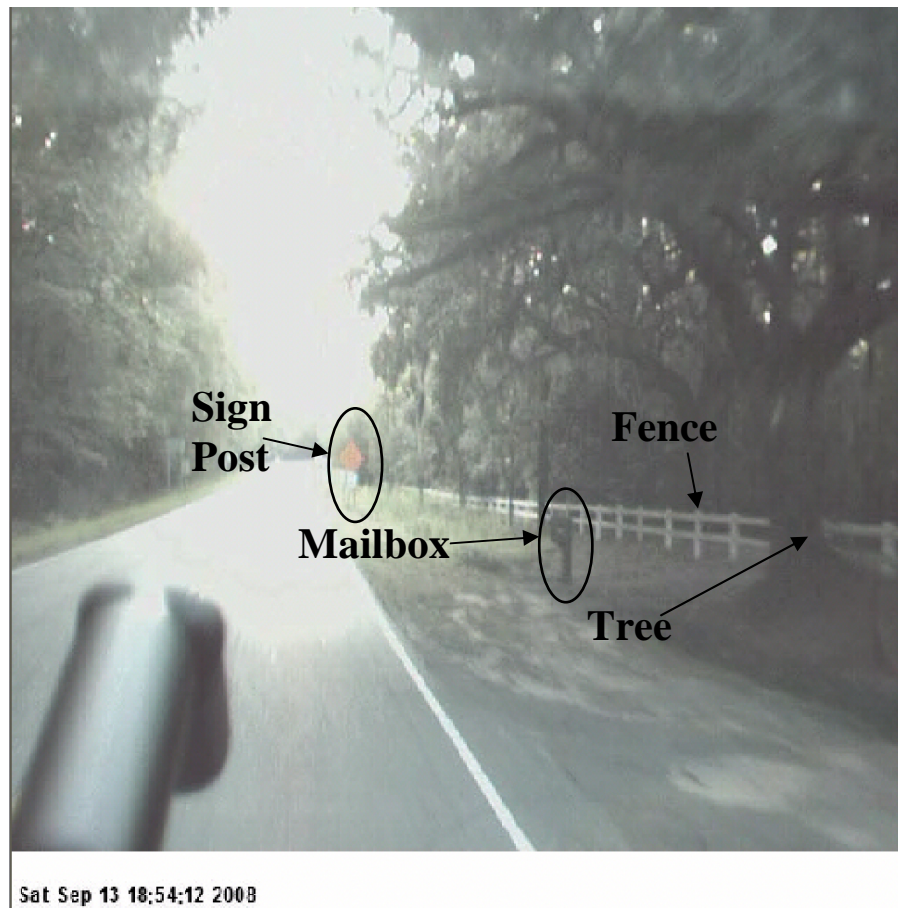
Figure-12, Obstacles other than trees on the roadside.

The analysis of 51 tree crash sites revealed that, 35 crash sites had more than one roadside obstacle (3 sites with 4 obstacles, 7 sites with 3 obstacles, 25 sites with 2 obstacles and 16 sites with only 1 obstacle). Obstacles other than trees were observed at the sites which included ditches, mailboxes, culverts, poles and traffic sign posts. Figure-13 below shows a number of obstacles observed other than trees on a site with accident ID 4006214.

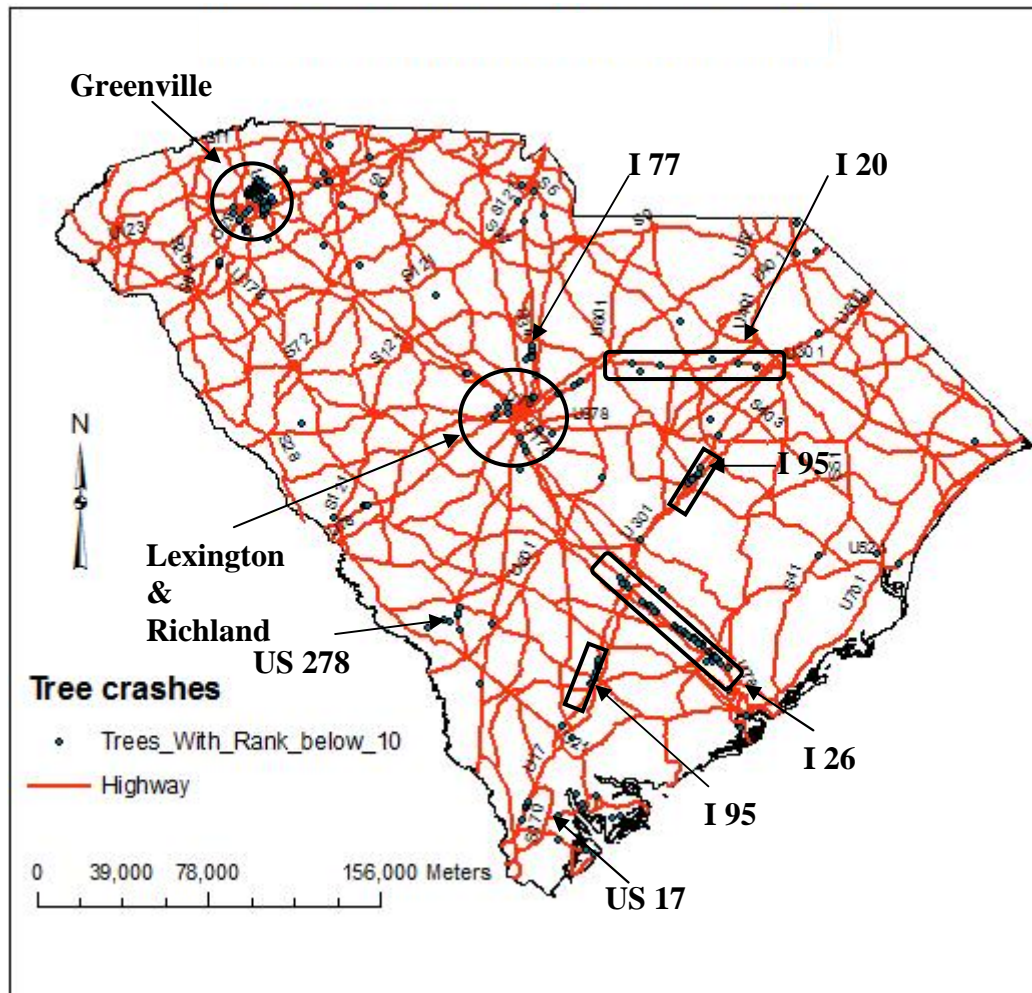
Figure-13, spatial location of tree crashes with rank less than 10.

Figure-13 below shows the details of these locations.

Majority of the tree crashes were located in the counties of Greenville, Richland, and Lexington. Since Greenville and Columbia are major cities in the state the frequency of crashes are also high due to high volume of vehicles. Descriptive statistics of police accident reports also revealed that the county of Greenville, Richland and Lexington are the top three counties with highest number of tree crashes in the state. Table-39 below lists top 10 counties with roadside tree crashes. Approximately 50% of tree related crashes in SC occur in these 10 counties.

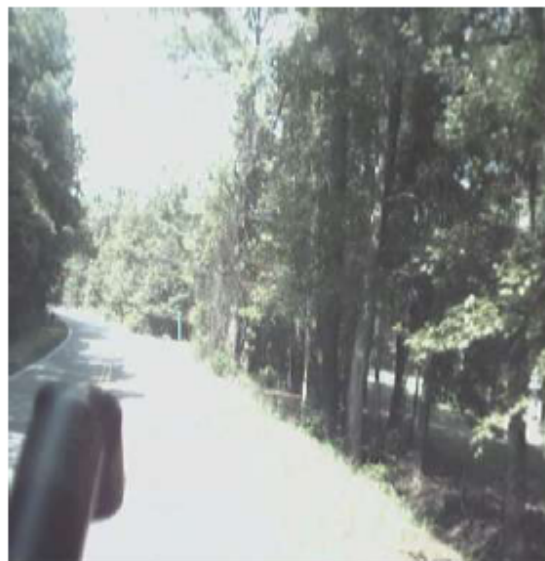
VIDEO -LOG PHOTO

SITE ID:
NSITE: 78Tree
LONGITUDE: -80173204
LATITUDE: 33323694
PRIMARY NAME: Short Cut RD
SECONDARY NAME:
ROUTE TYPE: Secondary
LANE 2
SPEED LIMIT (mph): 45
ADT: 1600
DIRECTION: NE
HRZL CURVE: Yes

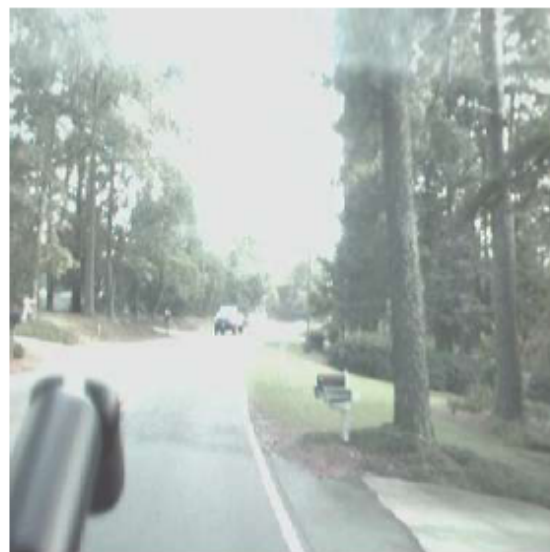
VIDEO -LOG PHOTO

SITE ID:
NSITE: 174Tree
LONGITUDE: -81696757
LATITUDE: 33525472
PRIMARY NAME: PowderHouse RD SE
SECONDARY NAME: State Highway 440
ROUTE TYPE: Secondary
LANE: 2
SPEED LIMIT (mph): 35
ADT: 1760
DIRECTION: SE
HRZL CURVE: Yes
